**NATIONAL REGISTER OF HISTORIC PLACES**

**Clinchfield Manufacturing Company Mill No. 2**

Marion, McDowell County MC0136 Listed 04/23/2024  
Nomination by Clay Griffith, Acme Preservation Services  
Photographs by Clay Griffith, January 2022

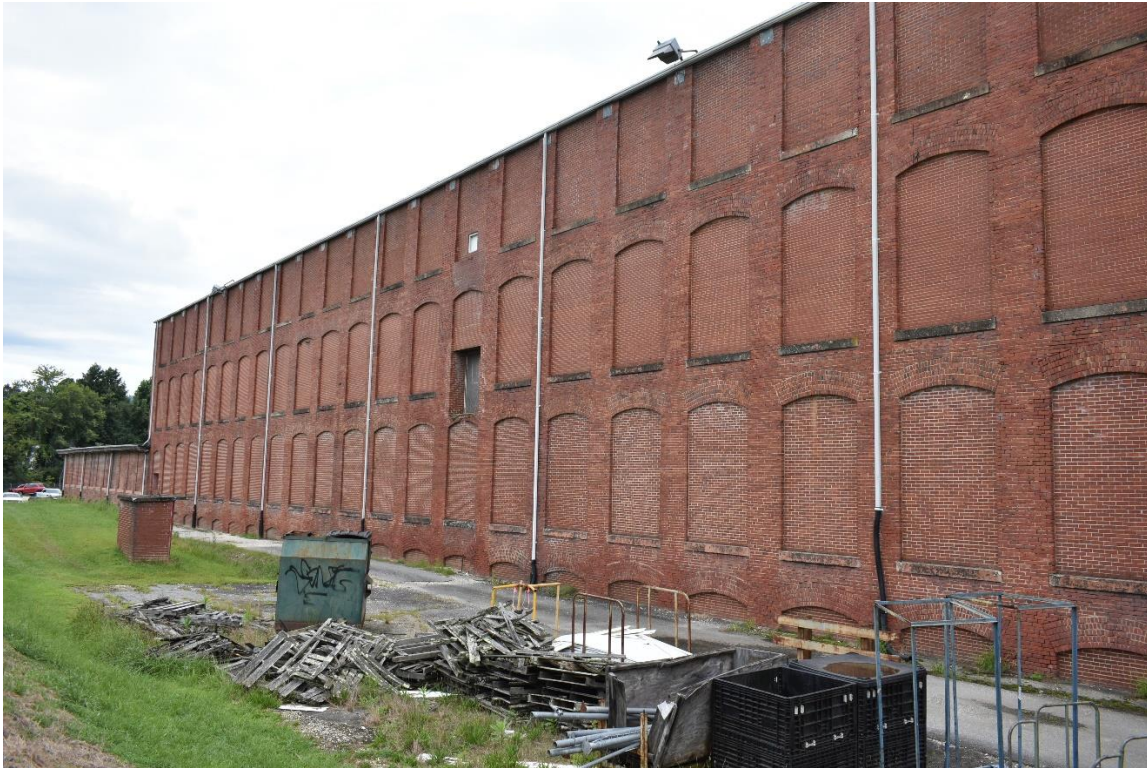
Mill No 2, east side elevation, view to southwest.

The north and east elevations of the mill are largely unchanged except for the enclosure of window openings. The rhythm and scale of the arched openings remains intact across three stories and a partially exposed basement level. At the north end of the east elevation, a concrete loading platform is sheltered by an attached, shed-roof metal canopy supported by bracketed wooden corner posts. A loading door fills one of the window openings. An area projecting from the four end bays of the east elevation is the starch house, which consists of a partially enclosed, unroofed, one-story space. A raised concrete platform is surrounded by brick walls with a terra cotta tile coping and openings at the north and south ends, as well as an opening at the north end of the east side. A concrete ramp accesses the area from the north side, and double-leaf glazed-and-paneled wooden doors with an arched transom fill the northernmost bay of the mill's east elevation. On the north elevation, the row of first-story windows are boarded over instead of bricked in and several window bays contain metal vents.

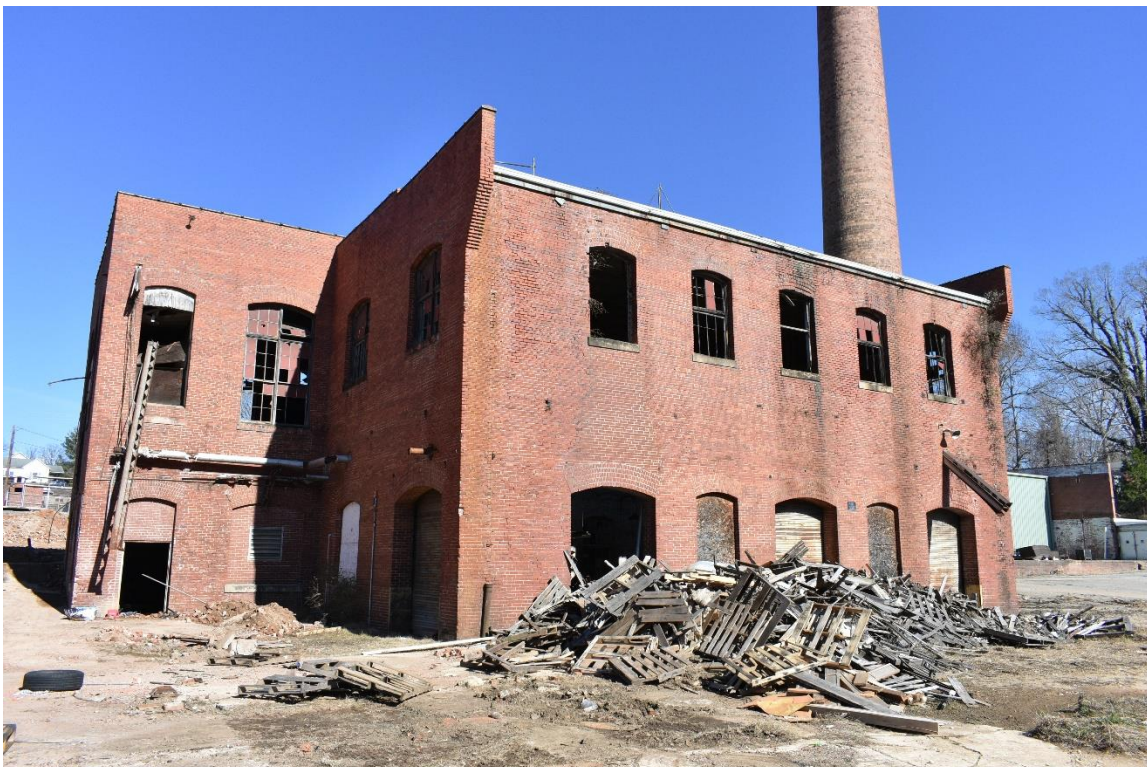
Boiler House, oblique view to northwest.

The two-story brick boiler house stands immediately north of Mill No. 2 and southwest of the cotton warehouse near the center of the complex and adjoins a 150-foot-tall brick chimney. Built at this location a short distance away from the mill, the boiler house was erected close to Mill No. 1's power plant to streamline the delivery and storage of coal for the boilers. Rectangular in plan, the boiler house is five bays wide on the long side elevations and two bays wide on the end elevations. A separate turbine house (identified as an "independent electric plant" on Sanborn maps beginning in 1918) attaches to the north elevation of the boiler house.<sup>1</sup> The turbine house, which is similar in scale and materials to the boiler house, is four bays wide with two bays extending beyond the northwest end wall of the boiler house. The buildings have a low-pitched gable roof with low, stepped end parapets and glazed terra cotta tile copings. The segmental-arch window and door openings are framed by five courses of header brick on the first story and four courses of header brick on the second story. The sills are cast concrete. The first-story entrance bays of the boiler house are accessible through metal overhead roll-up doors. Surviving original window sash in boiler house indicates an assortment of six-over-nine and eight-over-twelve double-hung wood-sash windows. The attached turbine house has paired nine-over-nine double-hung sash with arched six-light awning-style transoms and single twelve-over-twelve double-hung sash with eight-light transoms. The freestanding brick chimney

to the southeast tapers as it rises to a corbelled cap. It is attached to the boiler house by a horizontal vent connector encased in brick.

The boiler house was built in conjunction with Mill No. 2 as an independent power plant for the new unit. According to Sanborn maps, Mill No. 1 was erected with a dedicated power plant attached to the building. The engine room and connecting ropeway contained the drive belts necessary to operate the mill equipment. The boiler house and electric turbines generated electricity needed to run Mill No. 2. A railroad trestle on the south side of the boiler house allowed for the delivery of coal to the two power plants, which stood side by side but independent of each other. The fire that destroyed Mill No. 1 in 2019 charred a small area of the boiler house's west elevation, but otherwise the structure escaped additional fire damage.
