VANCE COUNTY COMPREHENSIVE ARCHITECTURAL SURVEY

PHASE ONE

May 2024

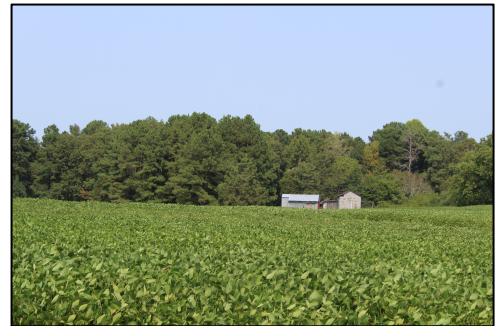
Figure 25: Claude Bobbitt House (VN0045) is typical of properties that were not accessible, for which photos were taken from the public right-of-way.

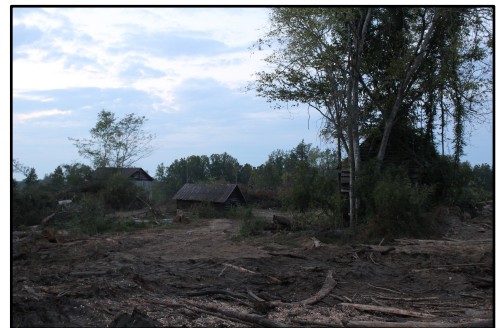
Figure 26: Hargrove House (VN0075)
Outbuildings were all that remained at the site in 2021.

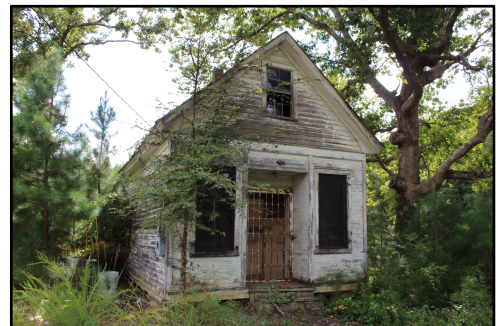
Figure 27: This store building is the only extant building in the Woodworth community (VN0146).

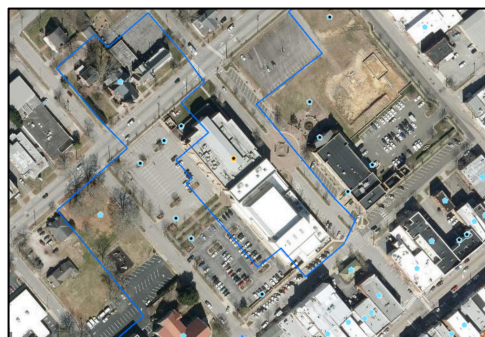
Figure 28: 200-blocks Breckenridge and Montgomery Streets
Historic resources were demolished (indicated by blue dots with black centers) for the construction of a municipal complex. Aerial imagery courtesy of NC OneMap (2019). North Carolina Department of Information Technology, Government Data Analytics Center, Center for Geographic Information and Analysis. Available at www.nconemap.gov with data points provided by HPOWEB 2.0, North Carolina State Historic Preservation Office, Department of Natural and Cultural Resources. Accessed from hpo.nc.gov/gis on April 1, 2024.

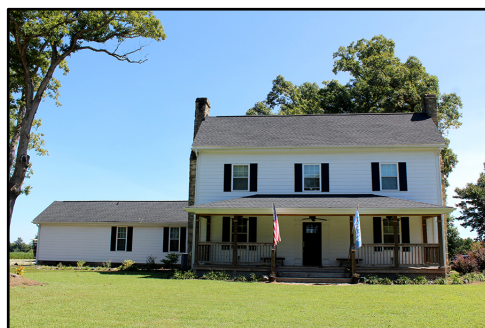
Of the previously surveyed properties, 125 properties (35 percent of the total) were classified as Substantial Change by Alteration. However, the classification is based on a comparison to archival photos and thus, the true number of altered properties may be underrepresented. The majority of the alterations are material changes, including the replacement of doors, windows, siding, or porches; however, in many cases the buildings have multiple altered components, resulting in a cumulative loss of historic material. Roughly one-fourth of the altered buildings are located in the rural parts of the county, where material alterations were not as common as demolition or loss. The other three-quarters of the altered buildings are located in Henderson, where commercial buildings and residences alike were routinely updated in the late twentieth century.

Figure 29: Currin House (VN0387) features replacement siding, windows, doors, and porch.

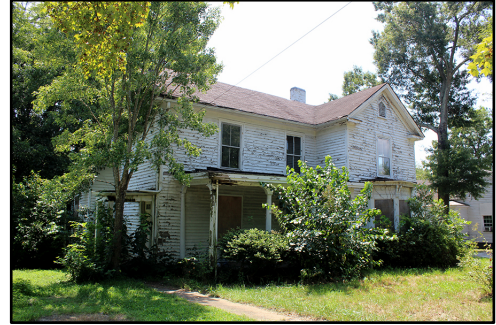
In addition to the 101 surveyed resources that have been demolished or otherwise removed from their sites, another sixteen buildings have experienced significant deterioration since the 1974-1975 and 1978-1979 surveys. Approximately half of these buildings are so deteriorated that, unless immediate stabilization and repair takes place, they are not likely to survive another five to ten years.

Figure 30: Bradsher House (VN0303)
Abandoned and overgrown, the house suffers from deferred maintenance.

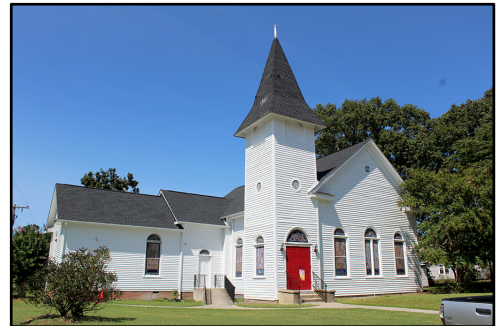
Figure 31: Middleburg United Methodist Church (VN0117) represents those properties that are unchanged since the previous survey.

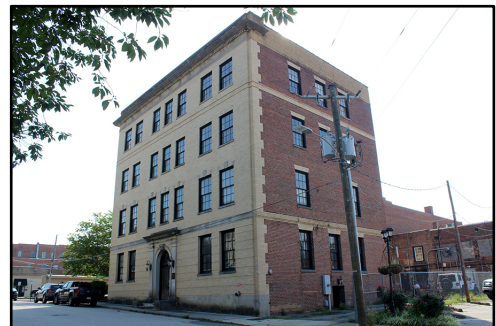
Figure 32: Professional Building (VN0332) was rehabilitated utilizing Rehabilitation Tax Credits.
